# Manhole Inspection Summary

Manhole # S17KK\_015MH

Insp Date: **3/3/09 1:11 PM**

**Location** Address: **1919 RUXTON AVE**

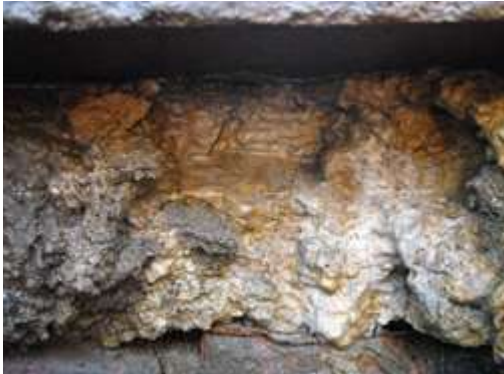
Defect 3

Infiltration: ☐ None ☒ **Joint** ☐ Cracks ☒ **Mortar** ☐ Roots ☒ **Wall**

EVIDENCE OF INFILTRATION BELOW FRAME

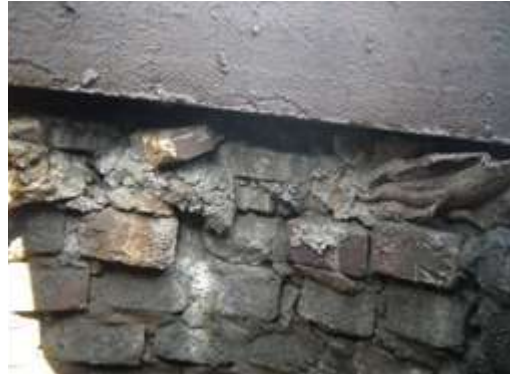
Defect 2

**Chimney / Frame Adjustment** ☒ Exists Material: **Brick and Concrete** ☐ Parged Height: **5** (in.)

Condition: ☐ Sound ☐ Cracked ☐ Root Intrusion ☐ Loose Brick ☒ **Deteriorated**

FRAME ADJUSTMENT 4" OF BRICK/STONE/CONCRETE IS DETERIORATED

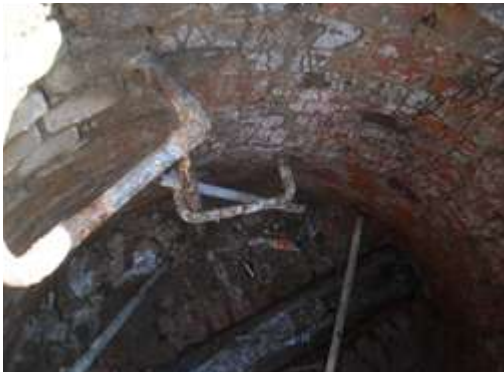
Defect 1

Condition: ☐ Sound ☐ Cracked ☐ Root Intrusion ☐ Deteriorated ☐ Leaks ☒ **Debris**

**Steps** Count: **2** Missing: **0** ☒ **Corroded**

CORRODED STEPS AND DEBRIS ON BENCH

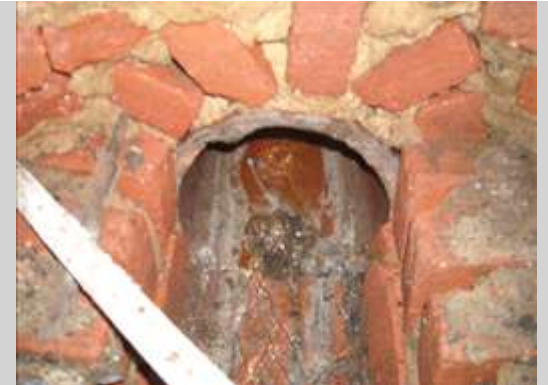
12 O'Clock Outflow

8 in. Circular Gravity Sewer  
Pipe Out @ 12 O'Clock

Pipe Height: **8.4** (in.) Rod and Bar (Angled)

Pipe Material: **Clay** ☐ Pipe Lined

Invert Depth: **5.72** (ft.) Flow Characteristics: **Slow**

Infiltration: **None** Pipe Seal Cond: **Sound**

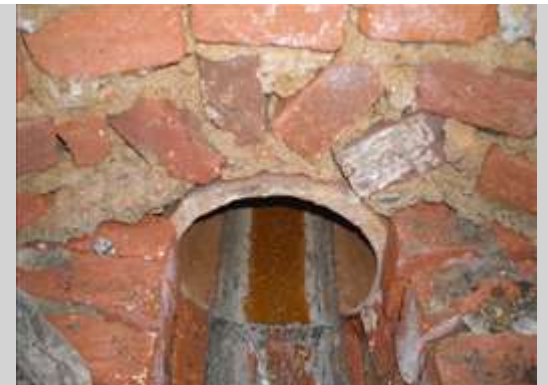
6 O'Clock Inflow

8 in. Circular Gravity Sewer  
Pipe In @ 6 O'Clock

Pipe Height: **8.4** (in.) Rod and Bar (Angled)

Pipe Material: **Clay** ☐ Pipe Lined

Invert Depth: **5.81** (ft.) Flow Characteristics: **Slow**

Infiltration: **None** Pipe Seal Cond: **Sound**
